**DEPARTMENT OF TRANSPORTATION****DIVISION OF ENGINEERING SERVICES**

Contract #: 04-0120F4Cty: SF/ALA Rte: 80 PM: 13.2/13.9File #: 69.28**WELDING INSPECTION REPORT****Resident Engineer:**Siegenthaler, Peter**Address:** 333 Burma Road**City:** Oakland, CA 94607**Report No:** WIR-021029**Date Inspected:** 24-Feb-2011**Project Name:** SAS Superstructure**OSM Arrival Time:** 700**Prime Contractor:** American Bridge/Fluor Enterprises, a JV**OSM Departure Time:** 1900**Contractor:** Zhenhua Port Machinery Company, Ltd (ZPMC), Changxing Island **Location:** Shanghai, China**CWI Name:** Zhou Zhong Hai**CWI Present:** Yes No**Inspected CWI report:** Yes No N/A**Rod Oven in Use:** Yes No N/A**Electrode to specification:** Yes No N/A**Weld Procedures Followed:** Yes No N/A**Qualified Welders:** Yes No N/A**Verified Joint Fit-up:** Yes No N/A**Approved Drawings:** Yes No N/A**Approved WPS:** Yes No N/A**Delayed / Cancelled:** Yes No N/A**Bridge No:** 34-0006**Component:** OBG COMPONENT**Summary of Items Observed:**

## WELDING INSPECTION REPORT

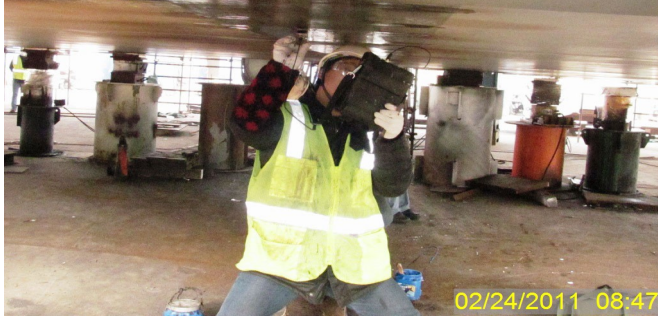
**The ABF QA inspector performed D-Scan Ultrasonic Testing for splice joint joining between bottom plate to bottom plate at segment 12BW to 12CW at trial assembly area**

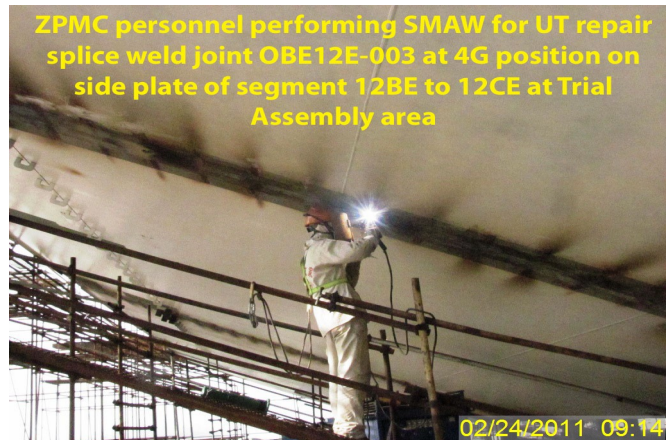
SMAW in the 4G position for the OBG Segment 12BE to 12CE ,UT repair weld No. OBE12E-003. The welder is identified as #040403. ZPMC QC is identified as Mr. Wang Li Yang. The welding variables recorded by QC appear to comply with WPS-345-SMAW-4G(4F)-REPAIR-FCM-1. The weld repair report is identified as CWR2812.The welding variables were recorded at, Amperage 157, volts 24.The In-process SMAW appears to be progressing in compliance with approved contract documents.

**ZPMC personnel performing SMAW for UT repair splice weld joint OBE12E-003 at 4G position on side plate of segment 12BE to 12CE at Trial Assembly area**
